Service Bulletin

Bulletin No.: 22-NA-124

Subject: Bolt EUV with Super Cruise Digital Map Control Module - Outdated Map Data

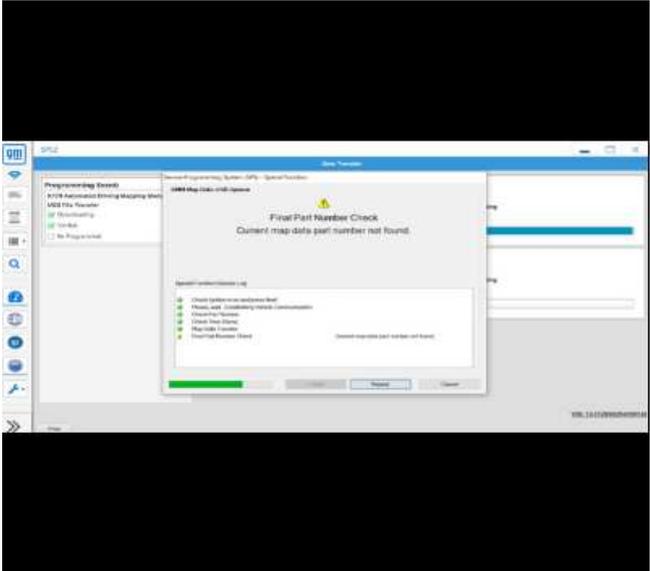
<p>Correction</p>	<p>First Condition: Discuss with the customer that this feature must be turned on for the vehicle to receive the automatic map updates to enable Super Cruise to function properly into the future. Please advise the customer to leave this feature selected to on.</p> <p>Second Condition: Dealers will update the map module with a USB update. It may be necessary to perform procedural steps multiple times in order for the update to be successful.</p> <p>Second Condition ONLY: Revised Procedure In Event of Programming Failure:</p> <ol style="list-style-type: none"> 1. Drive the vehicle for 5 minutes. 2. Setup Programming outside of garage. 3. Ensure “Share Hotpot” is off. 4. Run the Map Module – Programming - Refer to <i>K179 Digital Map Control Module: Programming and Setup</i> in the Service Manual. 5. Run the Map Module – USB - Refer to Digital Map Module Map Update 6. If USB fails, immediately start over with SPS running (without key cycle). Hit the CANCEL button. DO NOT HIT THE REPEAT BUTTON.

<p style="text-align: right;">6101178</p> <ul style="list-style-type: none"> • Run Map Module – Programming - Refer to <i>K179 Digital Map Control Module: Programming and Setup</i> in the Service Manual. • Run Map Module - USB - Refer to Digital Map Module Map Update. Note: Upon successful completion of all repairs, turn “Share Hotspot” back on.

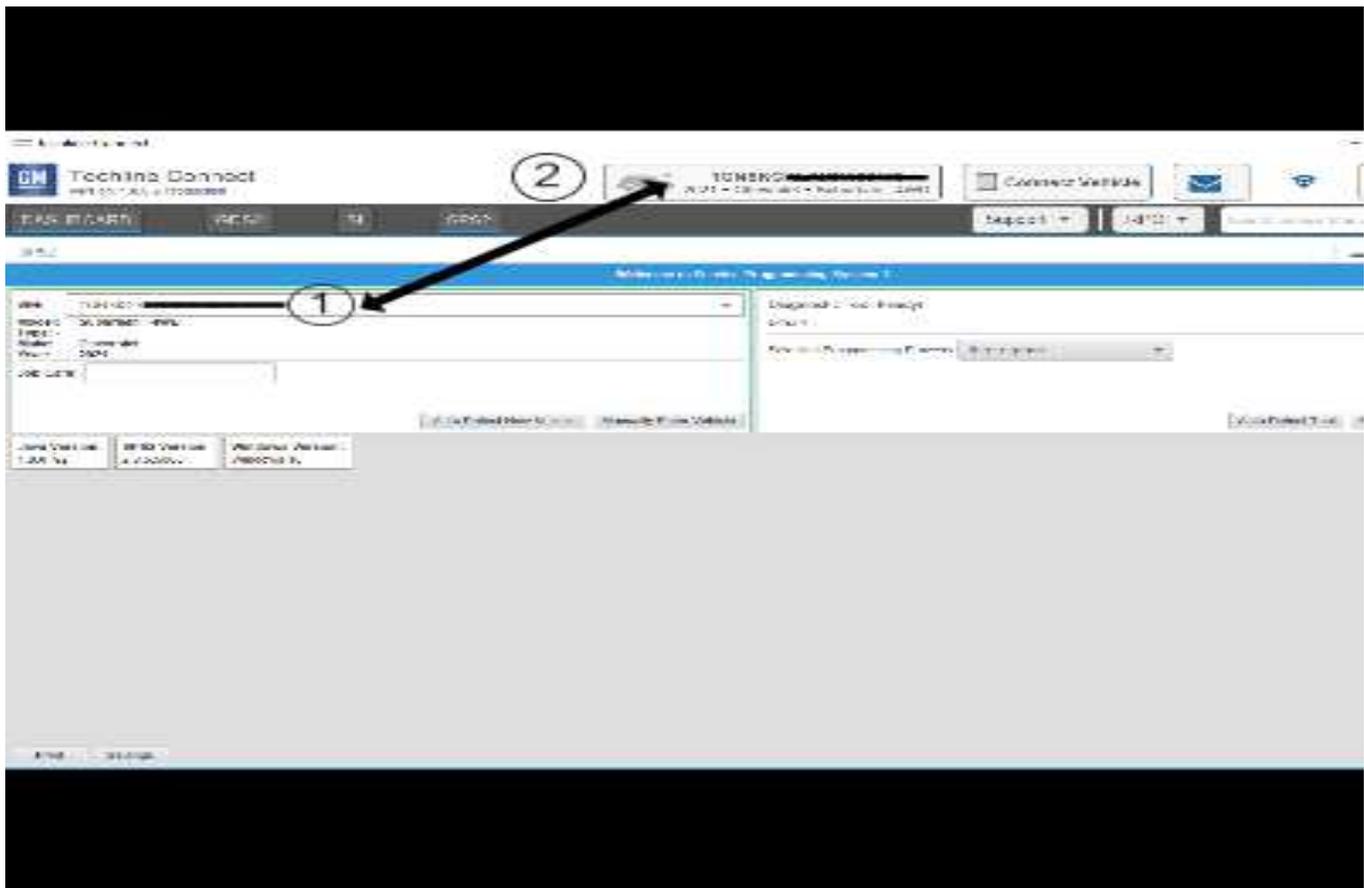
Caution: Be sure the VIN selected in the drop down menu (1) is the same as the vehicle connected (2) before beginning programming.

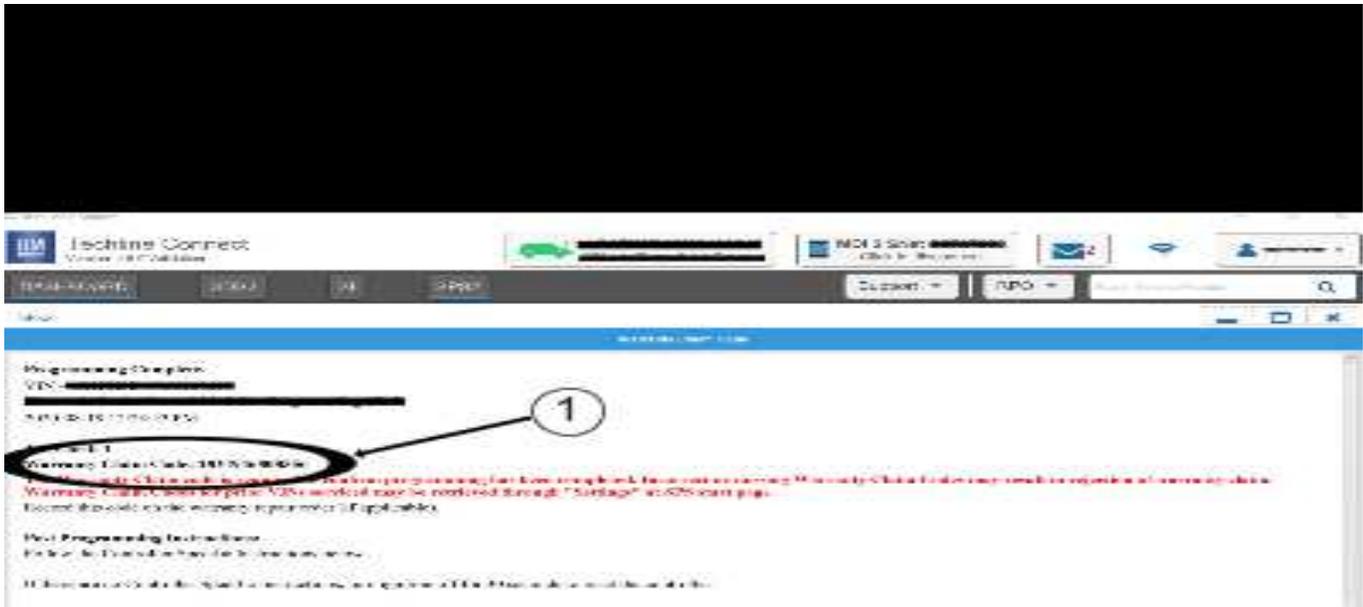
Note: The screenshot above is an example of module programming and may not be indicative of the specific module that is being programmed. Module selection and VIN information have been blacked out.

Important: To avoid warranty transaction rejections, you **MUST** record the warranty claim code provided on the Warranty Claim Code (WCC) screen shown above on the job card. Refer to callout 1 above for the location of the WCC on the screen.

2. Record the Warranty Claim Code on the job card for warranty transaction submission.
